**SAS Superstructure**

**Daily Diary Report by Bid Item**

Contract No.: 04-0120F4

Diary #: 138 Const Calendar Day: 374 Date: 17-Sep-2010 Friday

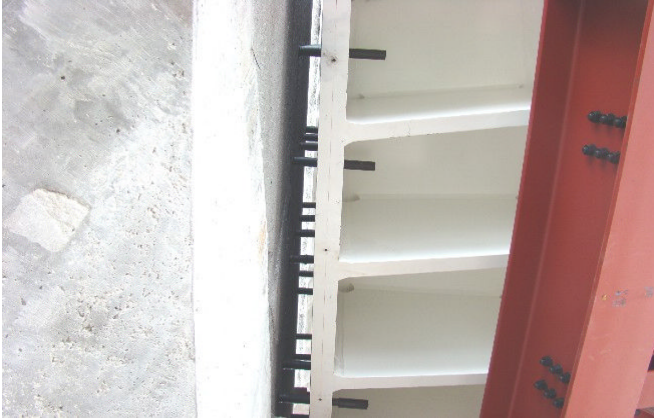
W2W2 saddle segment placed over the anchor rods. The placement appeared to go smoothly without any abrupt impact to the anchor rods.

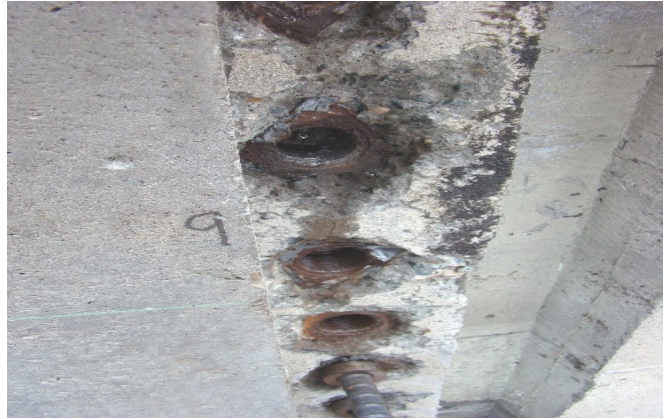
- Resumed cleaning the threads of the female HRC couplers for the bikepath lower pedestal located on the southeast end of the W2 cap beam.
- Placed the majority of the #25 male HRC couplers with T-heads for this particular blockout. A few of the threads of the embedded female couplers were damaged and therefore the bar wasn't placed. A thread chaser would have to be used to facilitate the placement of these bars, see photo below for more details.

Damaged HRC female couplers embedded into concrete for the lower bikepath pedestal on the southeast end of the W2 cap beam.

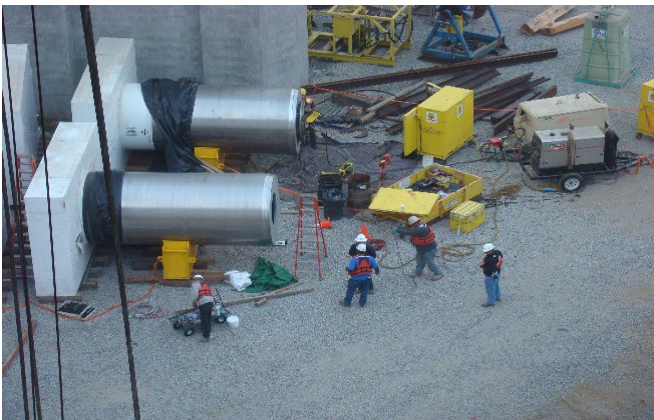
IPMC cutting the bevel for the second pipe beam and Certified Coatings painters beginning work on the first pipe beam.

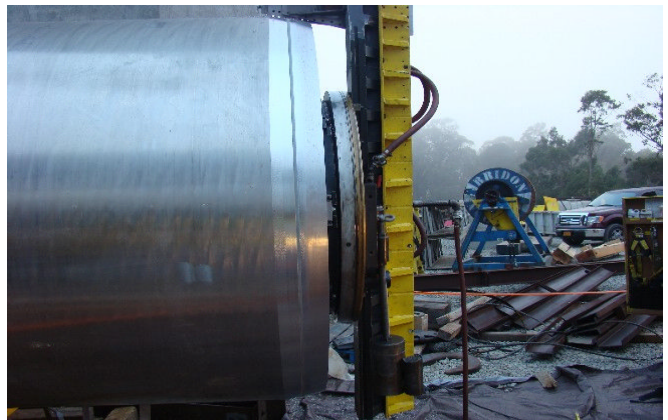
Progress of cutting the second bevel for the second Hinge K pipe beam at the start of the day.

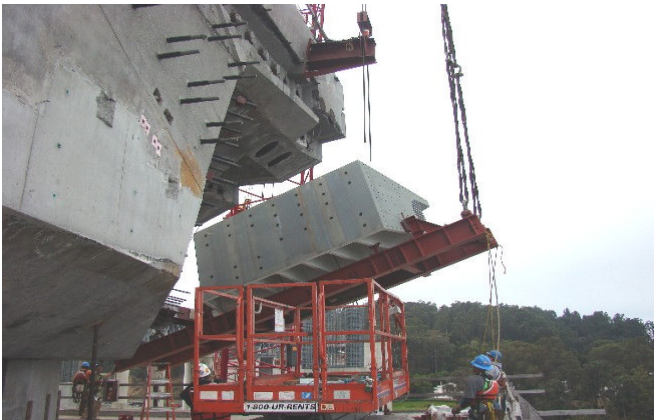
ABF ironworkers beginning to maneuver the W2W2 saddle segment to be placed over the anchor rods. Minimal rust was seen on the base plate of the saddle.

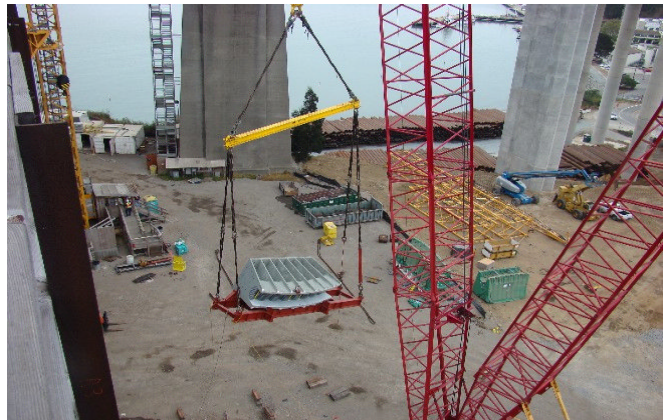
First attempt to erect the W2W2 west deviation saddle segment.

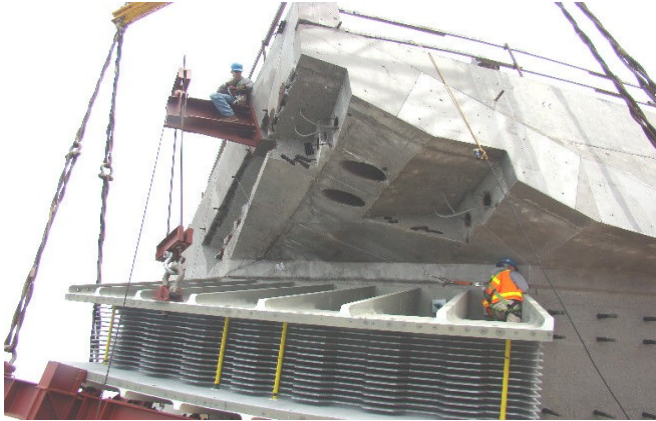
The saddle segment was surveyed/adjusted a few times after initial erection. The saddle segment was 1/2" from its theoretical position from W2.

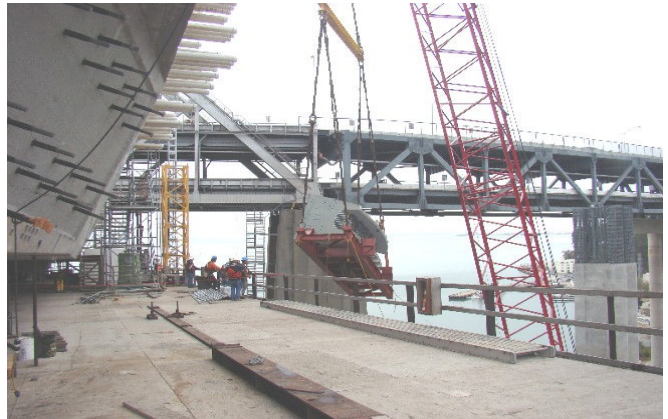
Second attempt to erect the W2W2 saddle segment after the rigging was shortened 50' to 30' from the cradle to the spreader beam.

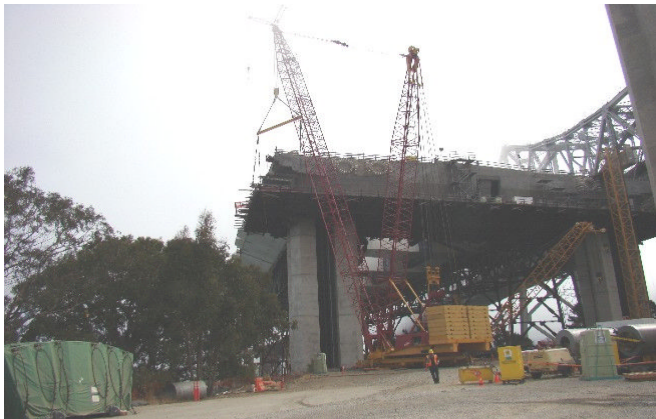
W2W2 saddle segment in place and secured to the W2 cap beam.

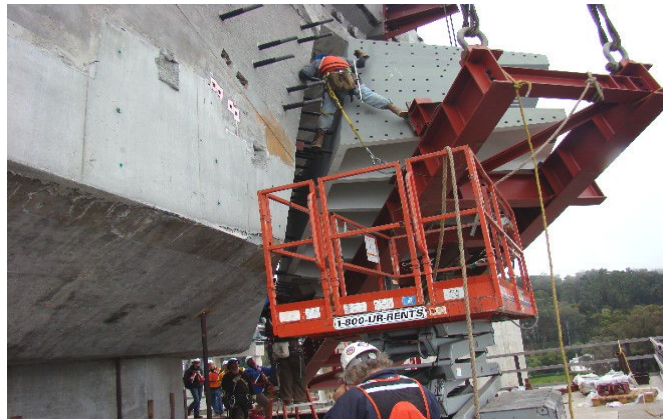
ABF ironworkers in the process of maneuvering the W2W2 saddle segment over the anchor rods.

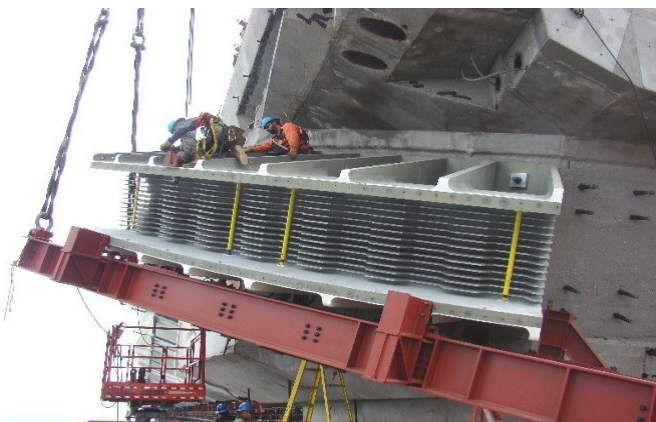
ABF ironworkers beginning to secure the anchor rod plates and nuts to the saddle segment.

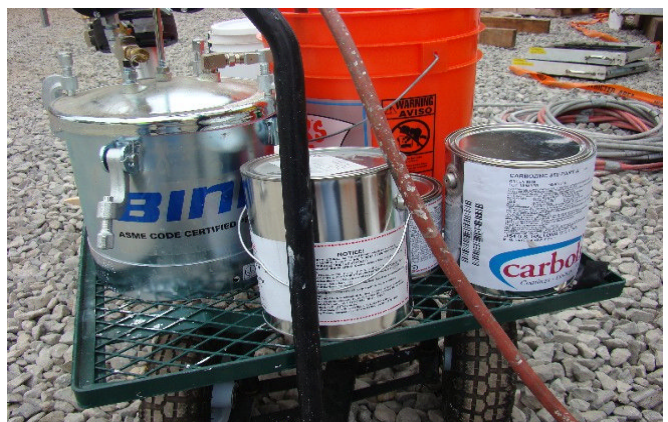
Paint and equipment used for the first Hinge K pipe beam.

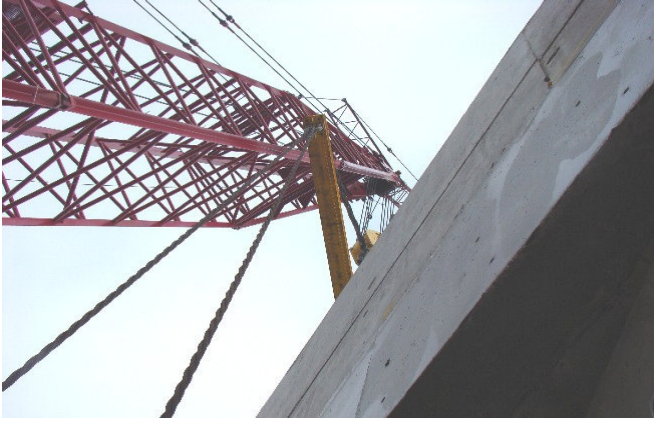
There was a conflict between the spreader beam and the boom of the Manitowoc ringer crane during the first erection attempt of the W2W2 saddle segment

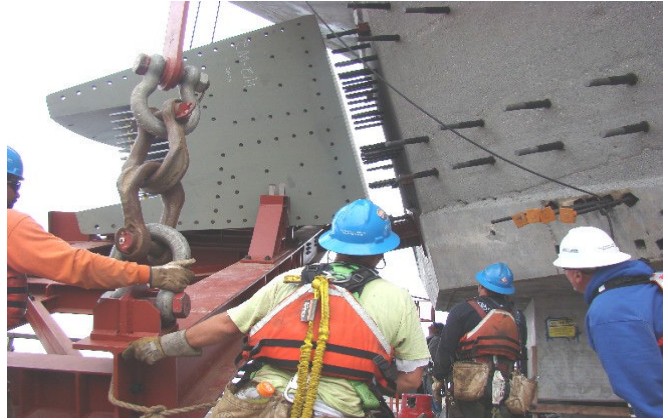
ABF ironworkers continuing to maneuver the W2W2 saddle segment to be placed over the anchor rods.
